8509 Scarboro Court
Box Area 33-05
April 24, 2011
House Fire with Civilian Death
Incident Number 11-0044722

Submitted by Battalion Chief Barry C. Reid
Incident Commander

**8509 Scarboro Court
House Fire with One Civilian Death
April 24, 2010
11-0044722**

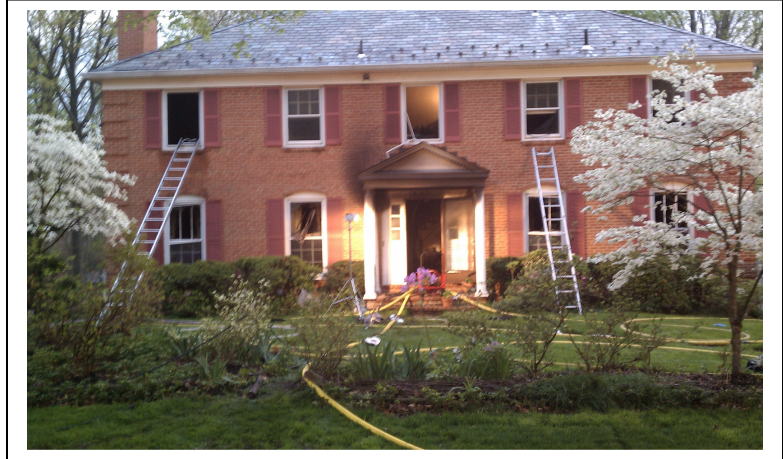
On April 24, 2011 at 04:35 units were dispatched for a house fire to the rear of 10416 Gainsborough Court. While units were en route, the Emergency Communications Center (ECC) received additional information placing the incident at 8505 or 8509 Scarboro Court.

Units were following appropriate SOPs and communicated water supply instructions for the revised address on Scarboro Court. At 04:41, Engine 733 arrived and reported a two-story house with fire and smoke visible at the front door. The address was confirmed (8509 Scarboro Court), command was established in the attack mode, and the appropriate accountability report was transmitted.

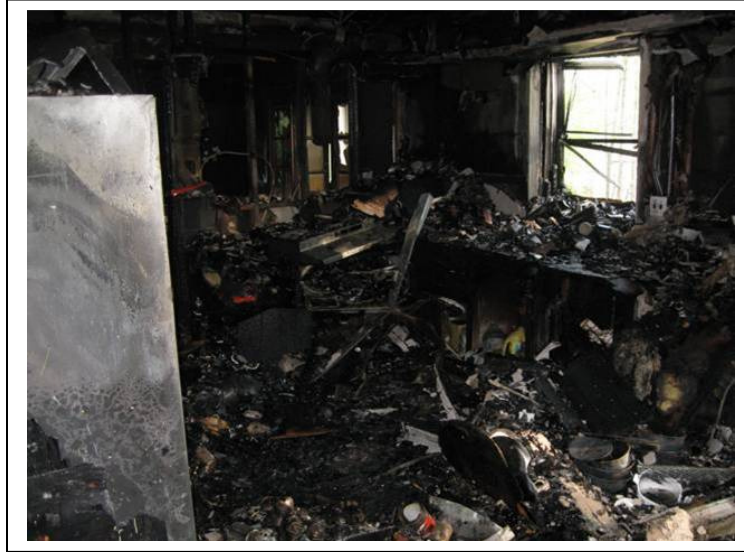
The victim on the second floor was transported to Suburban Hospital where he was pronounced. According to investigators, he had suffered significant burns from high-heat but not direct flame contact. The cause of death was later determined to be smoke inhalation.

It was also determined that a friend of the deceased was in the home at the time of the fire. First arriving units observed a number of bystanders near the scene but none gave any immediate indication that they were in the fire building. Nor did anyone indicate that there was someone still in the fire building. It was later determined that the survivor was sleeping in the basement, woke up and smelled smoke then exited through the basement garage. He was also transported to the hospital for a check up.

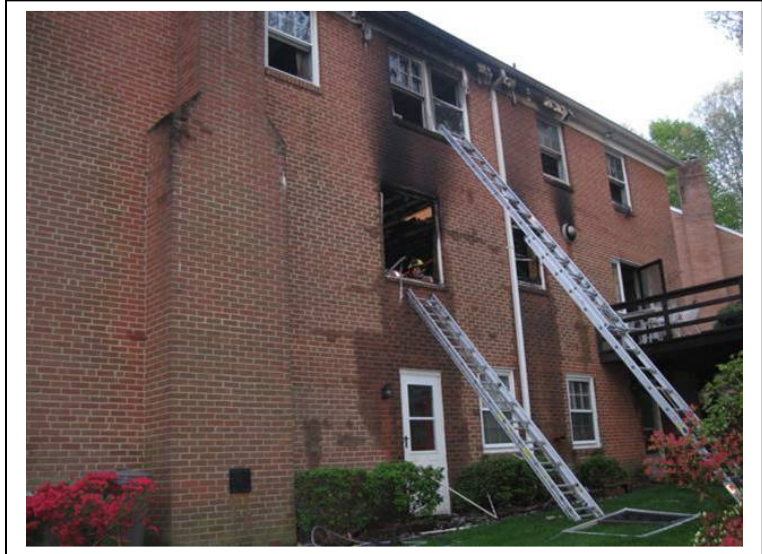
- (1) The primary supply line became entangled under T710 – picked up by the dual wheels.

The contribution of special services can not be over emphasized. It is understandable to try to fix your mistake. During the entire process, it was never directly mentioned (by radio) the cause of the interrupted water supply. E726 mentioned that the hydrant was OOS. E733's driver is warning crews of the impending dry spell. E726's driver did the right thing by hand-laying a line to give them a safety net with their tank water then E730's driver also provided E733 with water and ultimately an uninterrupted water supply.

Tactics still must be completed. Once it was realized that the hose was a lost cause, make a radio announcement and work around it. T710 should have continued with their assigned task.
